# ELECTROCHEMICAL REMEDIATION TECHNOLOGIES for METAL AND ORGANIC REMEDIATION IN SOIL, SEDIMENT, SLUDGE, AND GROUND WATER

**4<sup>th</sup> Symposium on the Hydrogeology of Washington State  
April 8-10, 2003 – Tacoma, Washington**

*William A. McIlvride<sup>2</sup>, Falk Doering, Ph.D.<sup>1</sup>, Niels Doering<sup>1</sup>,  
Donald G. Hill, Ph.D.<sup>2</sup>, Joe L. Iovenitti<sup>2</sup>,  
and J. Kenneth Wittle, Ph.D.<sup>3</sup>*

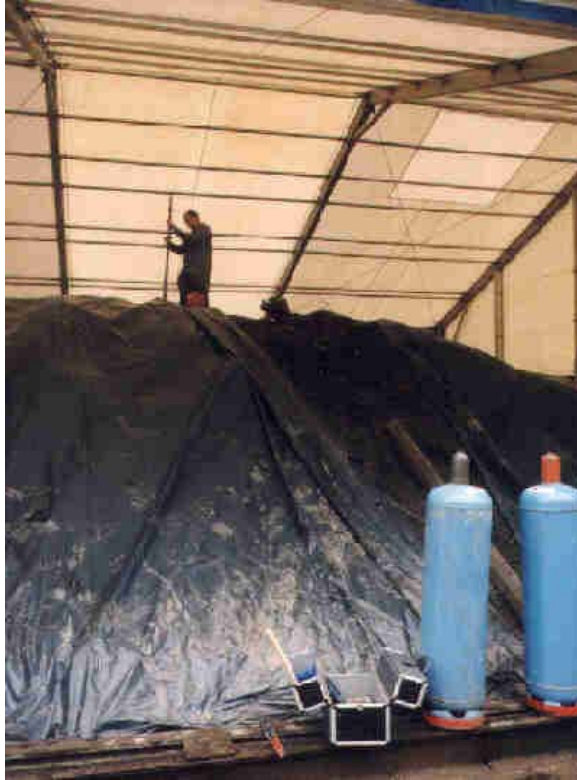
**Plan View**

**Cross Section**  
(all figures in meters)

500 tons of silty soil from unknown source. Particle sizes  $> 20$  mm had been sorted out. Main pollutants: PAH EPA 1-16. **Sampling and chemical analysis performed by independent accredited laboratory** as per Regulator's instructions **in compliance with German standard methods (DIN 38407 T8, HPLC with fluorescence detection)**. **Sampling: one composite sample comprised of the 3 cores of 8 different locations (18–23 kgs)**. Terms of operation: 70/100 days at 75 Volts dc, 8 Amps

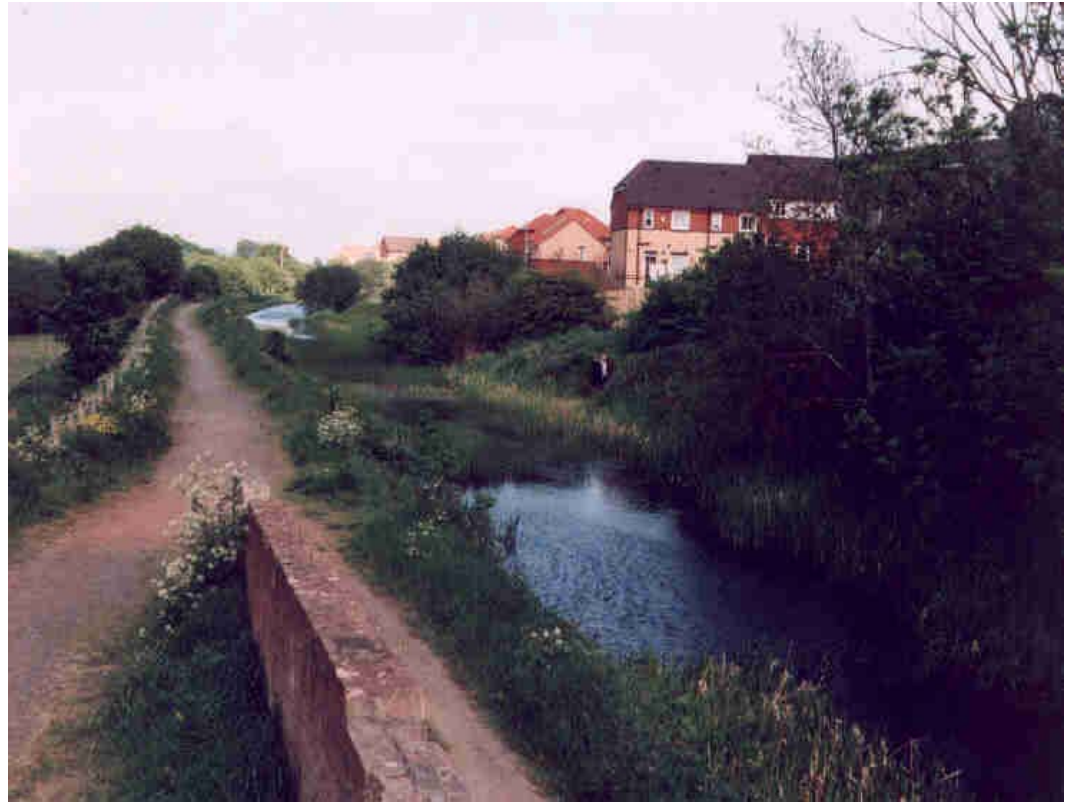
# UNION CANAL, SCOTLAND

❑ **Water TDS:** ~ 3.5 g/l  
mainly sodium chloride

❑ **Main Pollutants:**  
Elemental and methyl  
Hg

❑ **Electrodes:** Steel pipes  
192 mm OD, each 8 m  
long

❑ **Power input:** 5.6 kW

❑ **Sediment:** silts

❑ **Initial Average Total Hg Concentration:** 243 mg/kg

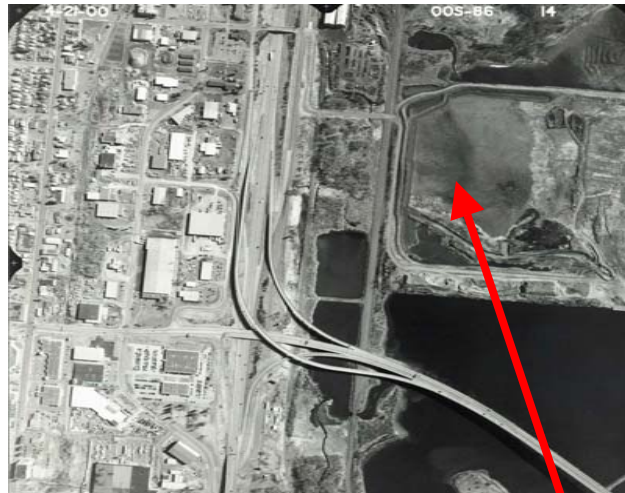
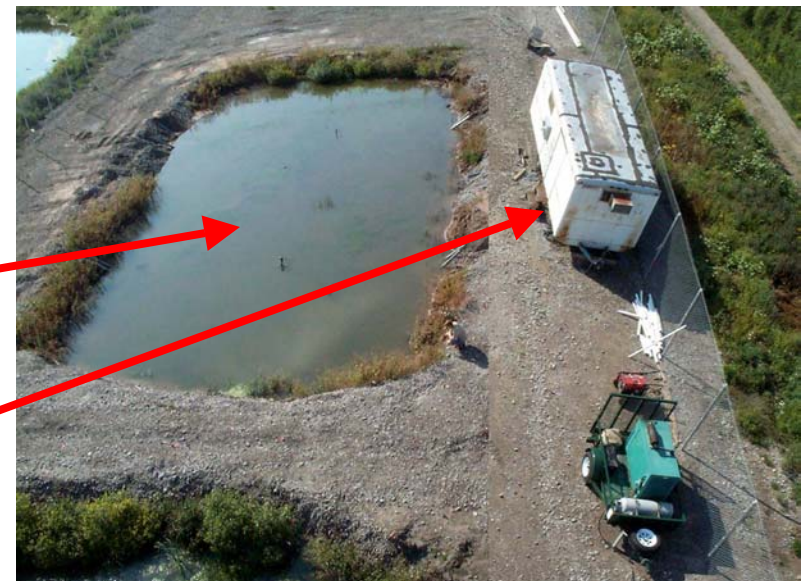
# ERIE PIER CDF, LAKE SUPERIOR

**Confined Disposal Facility  
(CDF)**

**Control**

**Test**

**Two Cells Created**

**Test Cell**

**Power Supply**

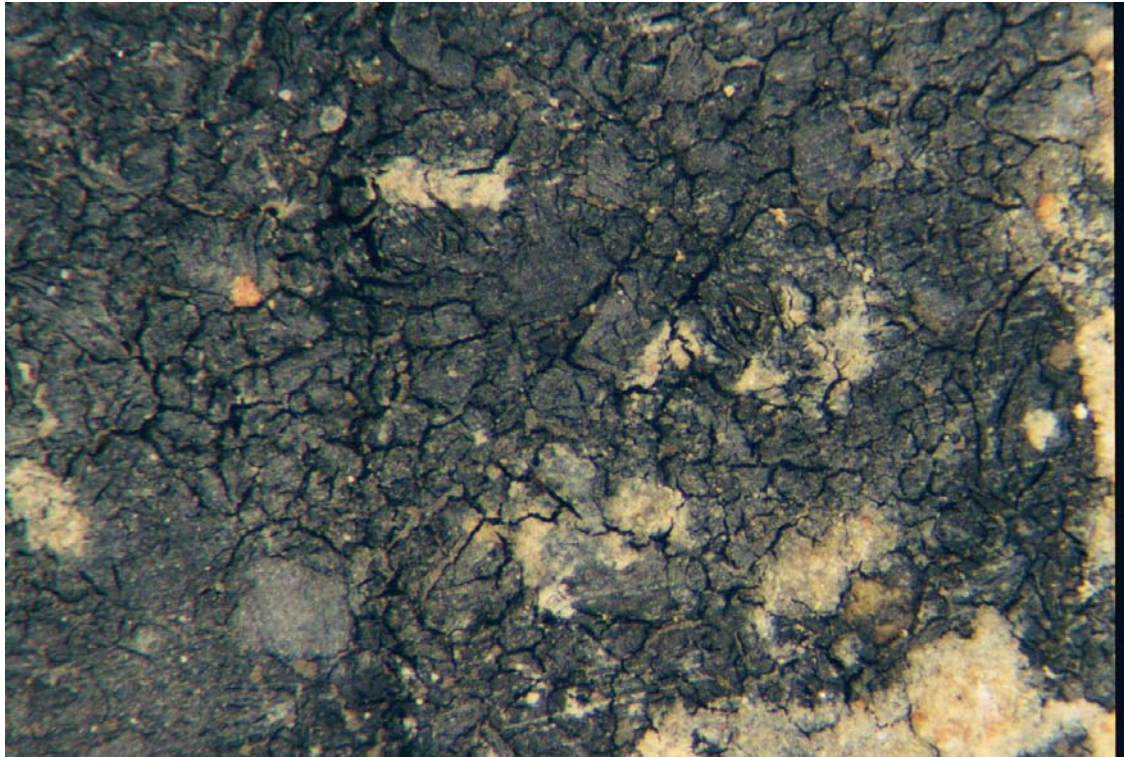
# ANODE PHOTOMICROGRAPH

□ Deterioration of Graphite Face and White Deposits, ~30X

Observation	Graphite Anode	Carbon Steel Cathode
Gross Appearance	Yellow-White Deposits	Pitting and Corrosion
Microscopic Appearance	Deterioration and Yellow-White Deposits	Mercury Metal Droplets
Mercury Vapor	0.002 mg/cu-m	0.075 mg/cu-m
Mercury Analyses	17.9–44.3 mg/kg	4.2–11.6 mg/kg
